WETLAND MITIGATION PLAN

**Williston Village RV Resort
Section 24, T155N, R101W
Williams County, North Dakota
Project #4554**

**Williston Village RV Resort
Wetland Mitigation Plan**

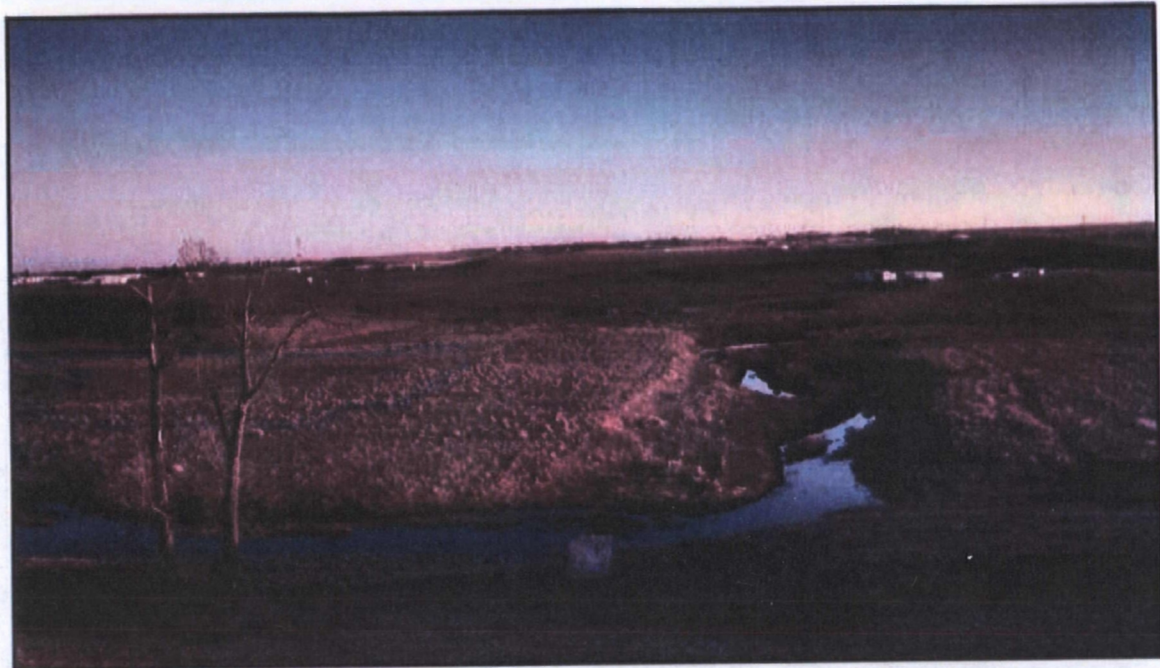
Photograph 1 - Mitigation Site 1

Photograph taken facing south toward the RV Resort. Mitigation Site 1 is an upland area adjacent to Camp Creek. Crested wheatgrass is the primary vegetation on the site. Excavation of the site would allow inundation by high flows back-flooding into it from Camp Creek. The high flows would also bring hydrophytic vegetation seeds into the mitigation wetland. The blue line indicates the approximate location and shape of Mitigation Site 1.

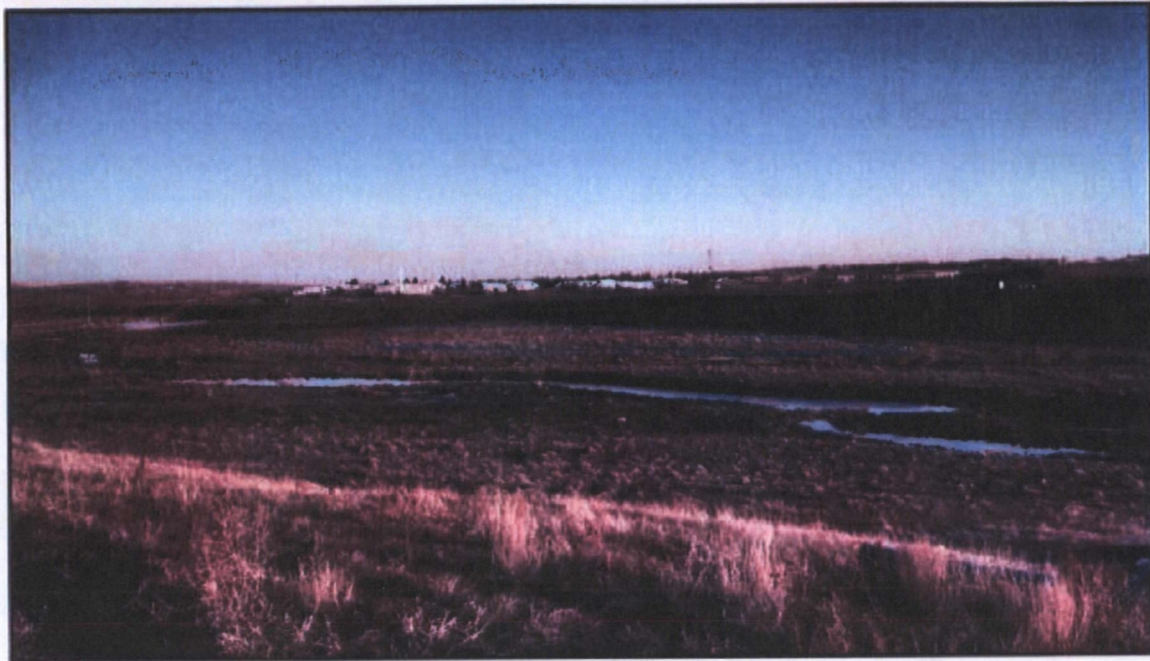
Photograph 2 – Mitigation Site 2

Photograph taken facing south toward the east side of the RV Resort. The mitigation site is a low elevation upland area adjacent to the associated wetlands of Camp Creek. Crested wheatgrass and western wheatgrass are present on the site. Excavation of the site would allow inundation and saturation from the adjacent wetlands. The adjacent wetlands would also be a source of hydrophytic vegetation seeds. The blue line indicates the approximate location and shape of Mitigation Site 2.

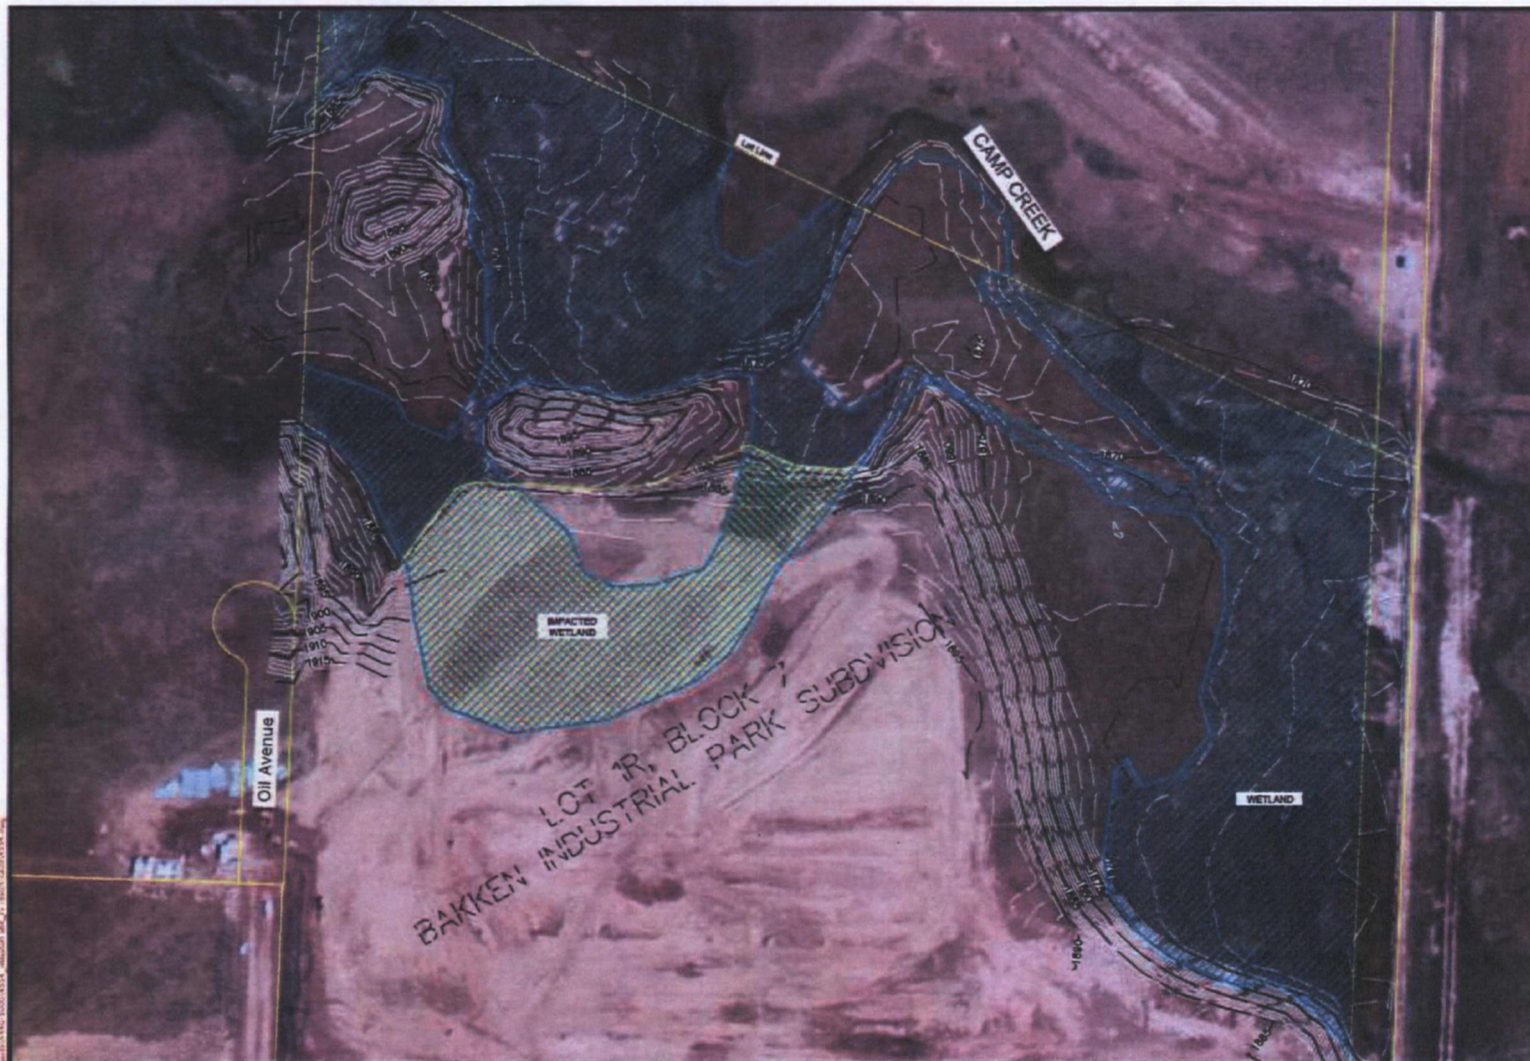
**WETLAND MITIGATION
EXISTING CONDITIONS**

1. CONTOURS SHOWN WERE DERIVED FROM FIELD TOPOGRAPHY (SHOT 6/5/2013).
2. 2012 NAIP AERIAL PHOTOGRAPHY SOURCE DATA.

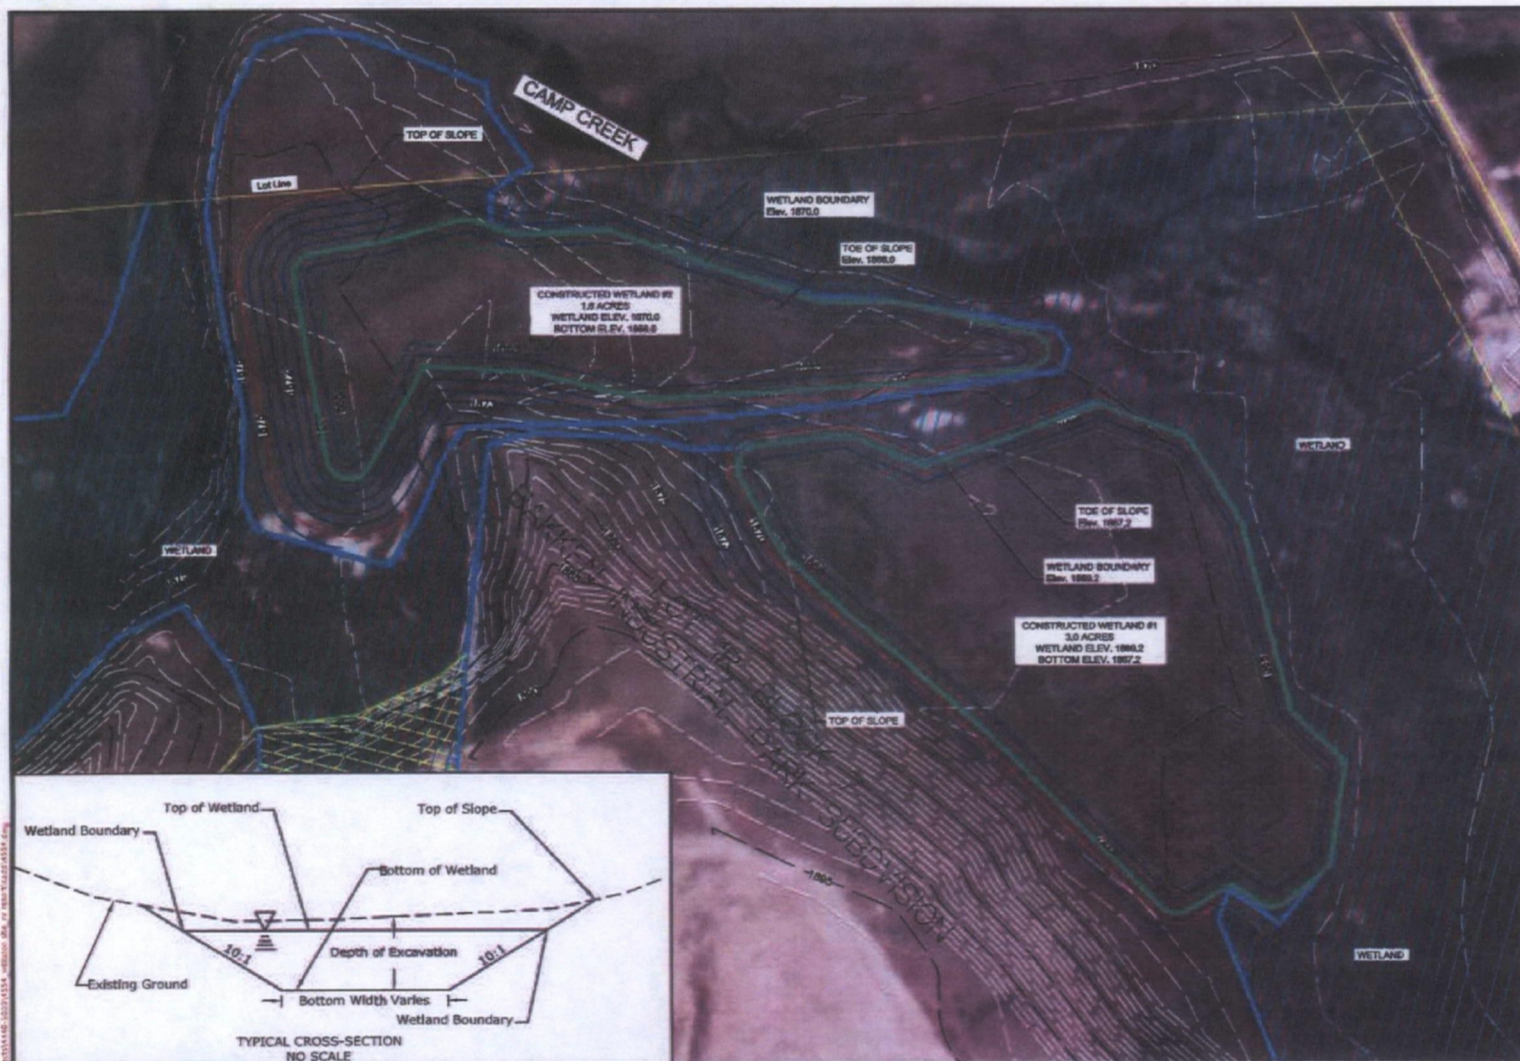
**WETLAND MITIGATION
 GRADING PLAN**

1. CONTRACTOR SHALL FIELD VERIFY ALL COORDINATES AND ELEVATIONS PRIOR TO STARTING CONSTRUCTION. DEVIATIONS FROM THESE PLANS SHALL BE BROUGHT TO THE ATTENTION OF THE ENGINEER BEFORE GRADING.
2. 2012 NAIP AERIAL PHOTOGRAPHY SOURCE DATA.
3. SEED ALL DISTURBED AREAS.

The mitigation plan includes excavating upland areas adjacent to Camp Creek and its associated wetlands. Water flow from Camp Creek and a high ground water table will provide hydrology to the mitigation wetlands. Topsoil will be removed and stockpiled nearby and then re-spread throughout the mitigation wetlands to ensure soil quality. Sub-soils will be removed and hauled away. Proposed grading plans are included in Appendix C.
